# PROPOSAL OF A SCHEME FOR CIRCULATION OF WATER IN THE TANKS OF BRAHMA SAROVAR AND SANNIHITH SAROVAR

## ABSTRACT

*The current study is to propose a scheme for the circulation of water between Narwana Branch canal at JyotisarTeerth and Brahma Sarovar and SannihithSarovar for maintaining proper quality standards in Brahma Sarovar and SannihithSarovar.*

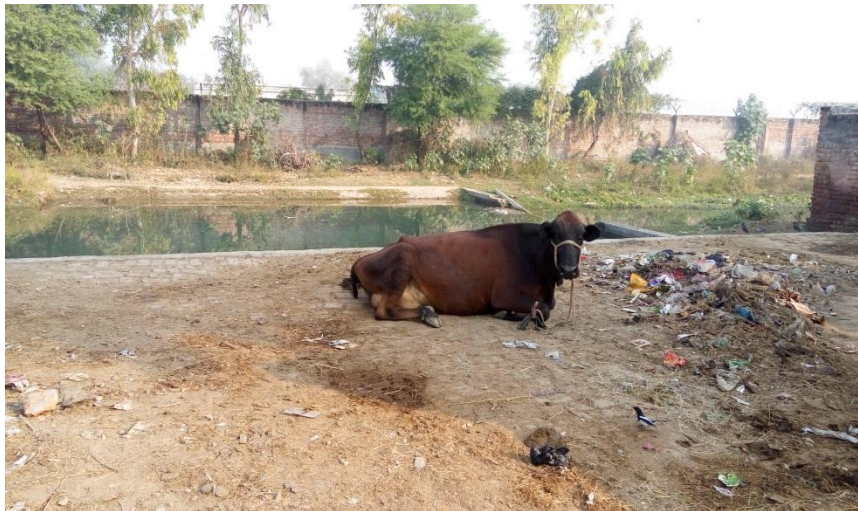
**Figure 3:** Cattle Farming at Mirzapur village

On its onward journey a total of 50 Cusecs of water is being carried by Thanesar Distributary which is an open channelled lined canal. Out of this 50 cusecs, 20 Cusecs are pumped into Brahma Sarovar and the rest 30Cusecs is carried forward for the purpose of cultivation and other needs. This canal on its way to Brahma Sarovarpasses through Mirzapur Village, Bhatta Colony and Kurukshetra University. In Mirzapur village it is being observed that the villages carryout cattle farming on the banks of the canal (fig 3) and it is also seen that they have dumped solid waste into the canal(fig 4). The canal before entering Kurukshetra University has a ghat where laundry work for a large number of clothes is carried out resulting in polluting the water with chemicals, detergents etc. (fig 5).

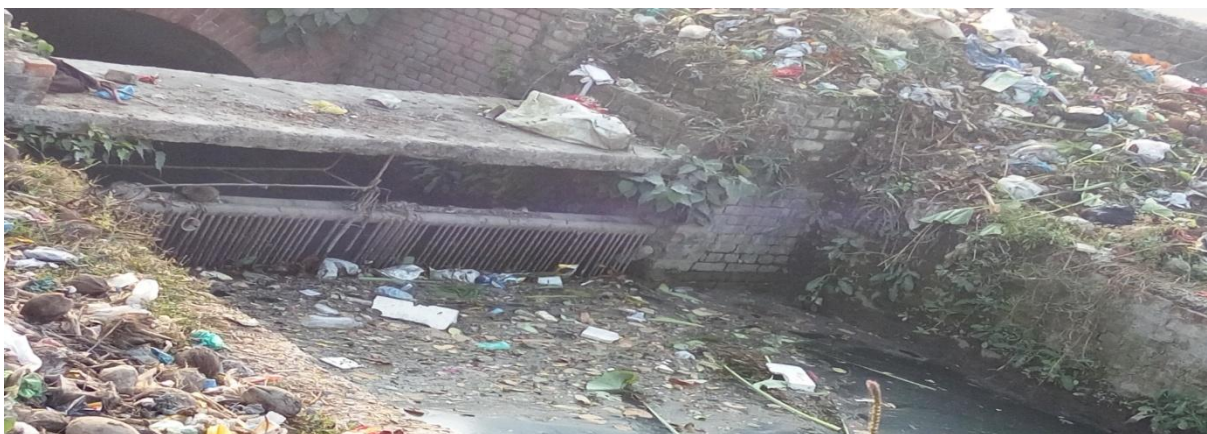
**Figure 4:** Garbage dumped in the distributary

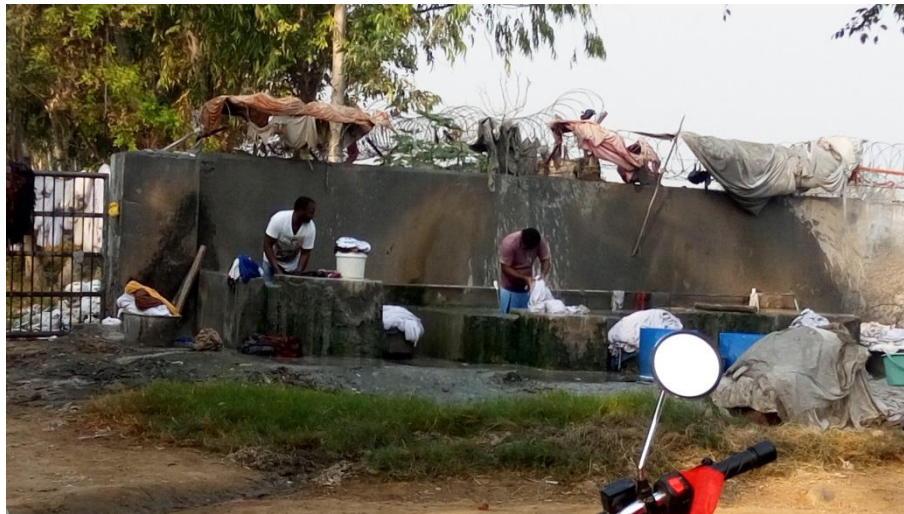
**Figure 5:** Laundry on the banks of distributary
